Continued Airworthiness Notification

Subject: Preventing Carbon Monoxide Poisoning in Piston Engine Aircraft

Airworthiness Bulletin

AWB 02-064 Issue 3 – 3 August 2021

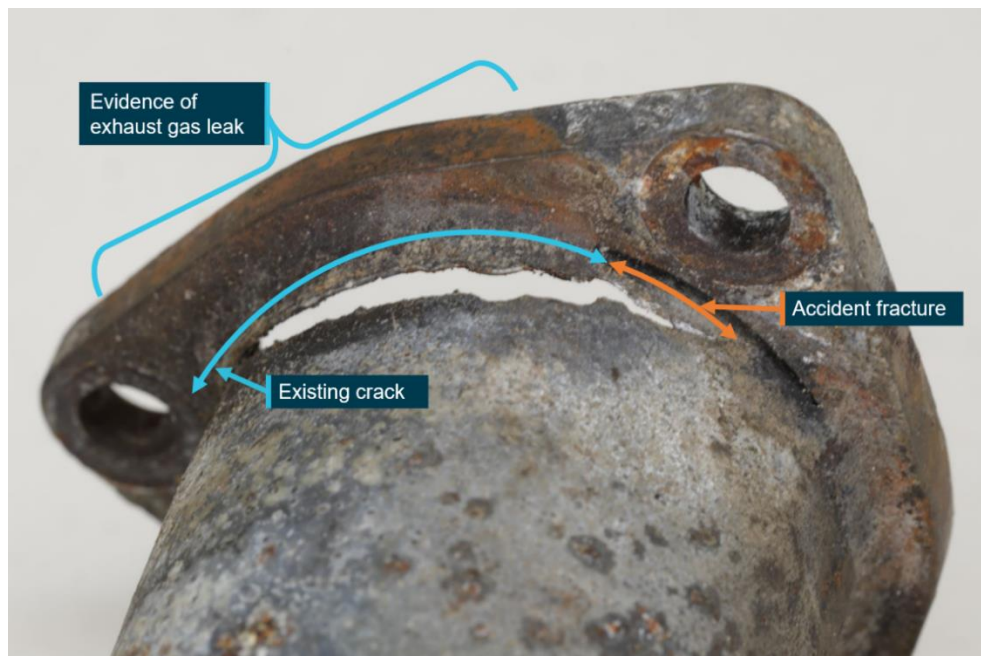
Figure 1

Engine exhaust unit potential to leak CO into the aircraft cabin. Image provided by Australian Transport Safety Bureau.

Firstly, the exhaust collector assemblies on piston powered aircraft are a known source of CO. Manufacturer's instructions for continued airworthiness (ICA) require regular inspection of exhaust pipe collectors and heat exchangers. Their useable life is centred on an "on condition" maintenance inspection philosophy and as such requires increased vigilance with ageing exhaust components.

The Civil Aviation Safety Authority recommends that when LAME/AMEs conduct visual inspections of exhaust collectors and heat exchange units, that a thorough inspection is conducted with the view of finding potential CO poisoning points/cracks. Whilst the internal condition and thickness of exhaust components is difficult to determine visually, if the component exhibits signs of thinning, cracking, bulging or any exhaust leakage the section should be removed and replaced with a new or serviceable/repaired item.

An ideal maintenance program would involve exhaust system replacement at engine change or at a predetermined interval gained from operating experience. To operate these items to a point of failure is not considered appropriate, the maintenance repair organisation or CAMO can instigate a periodic CO detection functional test during which the CO level in the cabin is measured. Quantitative CO must be used and the CO level entering the cabin must be less than 1 part in 20000 parts of air (equivalent to 50 parts per million).

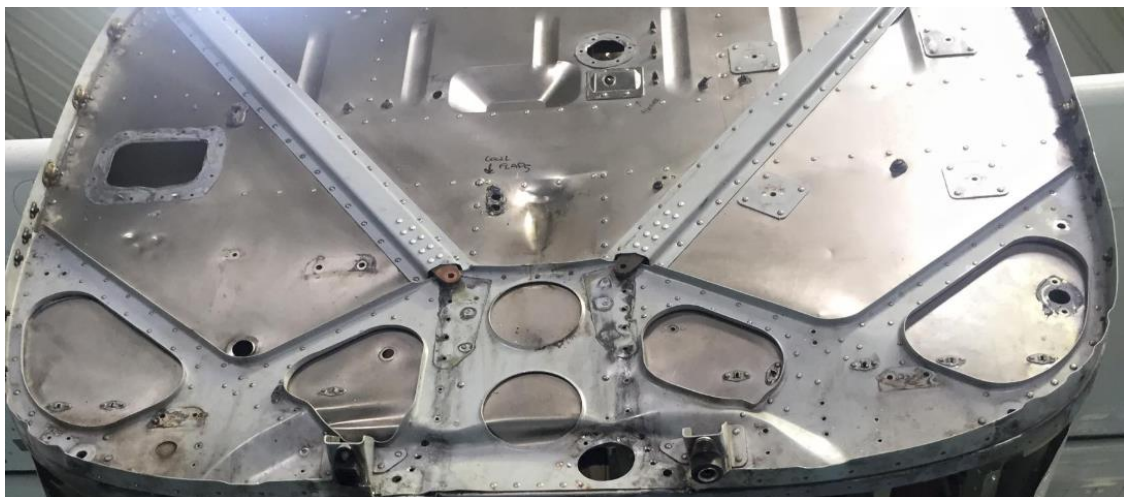
Figure 2

Secondly, the CO potentially enters the cabin either via heating ducting, open voids in the engine firewall or open doors and windows. Whilst the latter two are unavoidable, the firewall integrity, heating ducting and control valves need to be inspected to ensure correct operation and sealing. Modifications and access panels installed within firewalls for maintenance must be re sealed and secured correctly following all maintenance actions.

Engine firewall openings that may be required to be opened for maintenance and repairs must be correctly fastened and sealed prior to flight thus preventing CO from entering the cabin.

Approved modifications that include access panels and attachments to firewalls must be re-sealed following all disturbances to prevent CO entering the cabin. Heating ducts and on/off valves should function correctly, particularly in the off position to allow the pilot to stop the flow of contaminated air entering the cockpit. If an access panel on the engine firewall is opened/removed during maintenance/servicing for gaining access, ensure that the access panel seals/gaskets and hardware are reinstalled correctly to prevent the flow of gases and flammable fluids entering the cockpit and cabin.

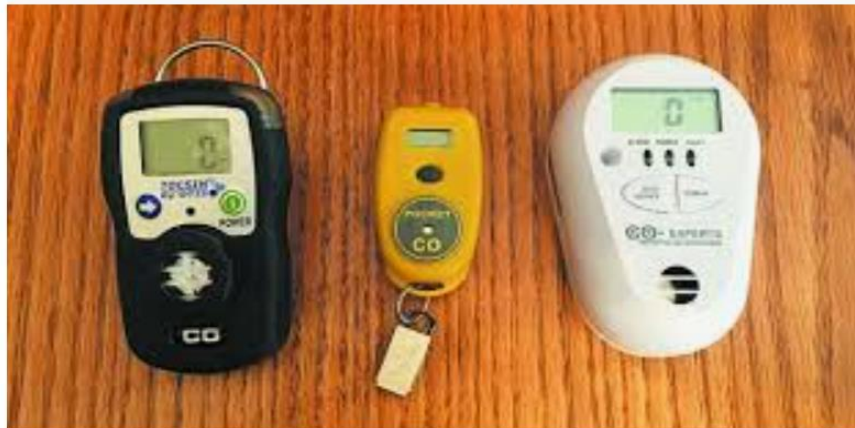
Figure 3

Electronic CO detector devices available for personal use.

CASA strongly recommends pilots wear personal CO detectors. As not all aircraft are required to have CO detectors fitted, small electronic personal devices are readily available at affordable prices. These devices allow for continual monitoring of CO levels with audible and visual warnings when escalated CO levels are detected.
