Airworthiness Directive

AD No.: 2022-0147

A318, A319, A320 and A321 aeroplanes

ATA 36 – Pneumatic – Overheat Detection System Sensing Elements – Inspection

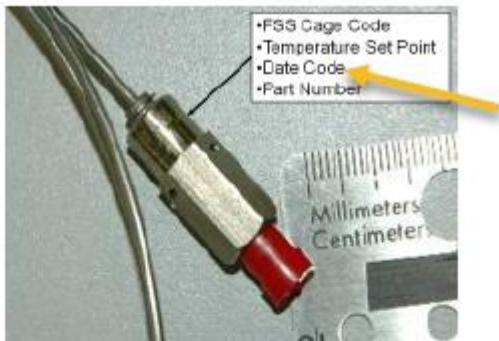
Figure 4-50. Identification Markings on Coaxial SE Male (Pin) Connector

Appendix 1 – Affected Part – Locations of P/N and Date Code
