[Docket No. FAA-2022-0891; Project Identifier AD-2022-00585-A,E,R; Amendment 39-22432; AD 2023-09-09]

Airworthiness Directives; Various Airplanes, Helicopters, and Engines

The FAA is adopting a new airworthiness directive (AD) for turbocharged, reciprocating engine-powered airplanes and helicopters and turbocharged, reciprocating engines with a certain v-band coupling installed. This AD was prompted by multiple failures of spot-welded, multi-segment v-band couplings at the tailpipe to the turbocharger exhaust housing flange (also referred to as “spot-welded, multi-segment exhaust tailpipe v-band coupling”). This AD establishes a life limit for the spot-welded, multi-segment exhaust tailpipe v-band coupling and requires repetitively inspecting the spot-welded, multi-segment exhaust tailpipe v-band coupling. The FAA is issuing this AD to address the unsafe condition on these products.

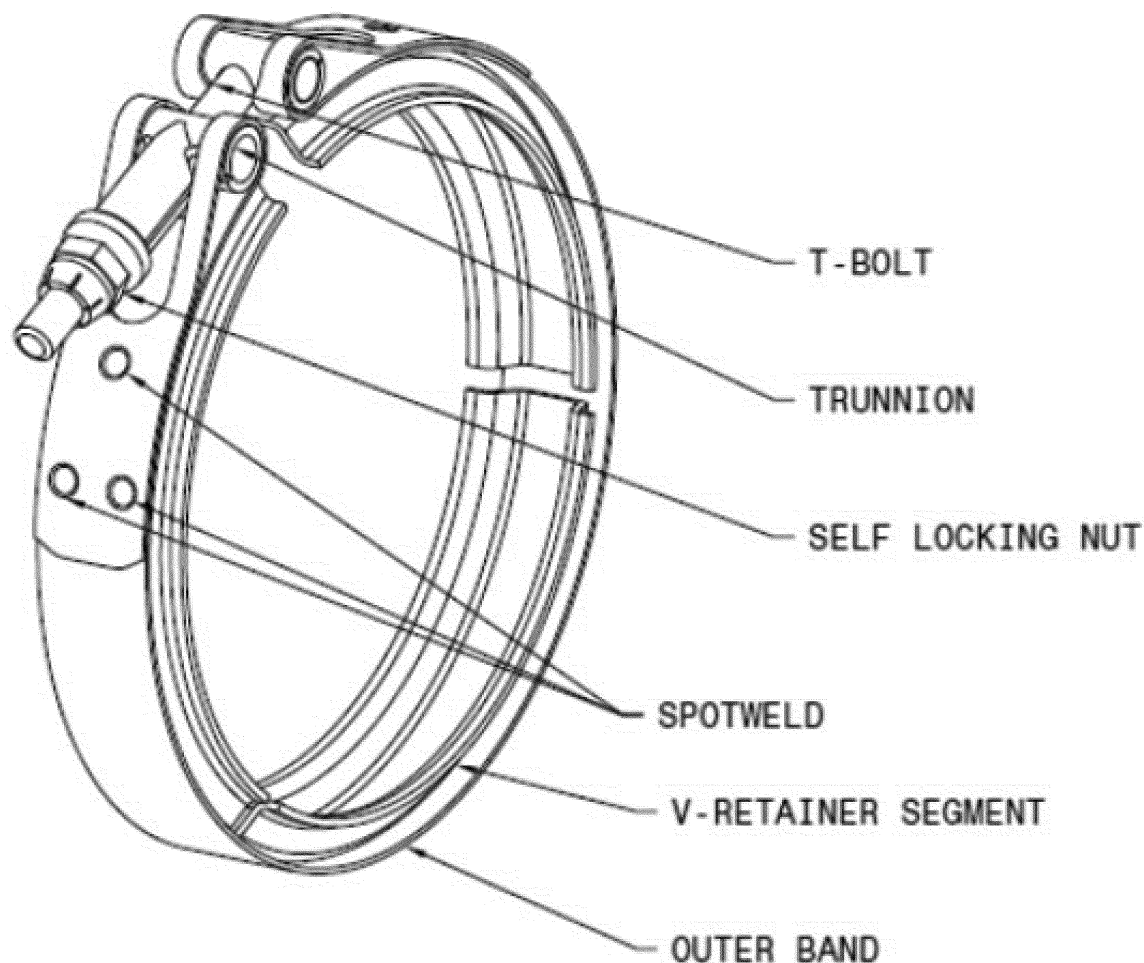
Figure A

The final report concluded that the common denominator in the incidents and accidents reviewed is the spot-welded, multi-segment exhaust tailpipe v-band coupling (see Figure A). These couplings come in either two or three segment varieties. The segments are the number of v-retainer segments,

Spot-welded, multi-segment exhaust tailpipe v-band coupling

The majority of the events studied by the working group indicated fatigue failure of spot-welded, multi-segment exhaust tailpipe v-band couplings as a result of stress corrosion cracking that originated at or near a spot weld. This is the same unsafe condition identified in the other v-band coupling AD actions previously referenced. The data studied by the working group contained evidence of pre-existing cracking of the couplings, known embrittlement at the spot weld locations simply due to that manufacturing method, and outer band cupping on the multi-segment couplings (which is the result of age, over-use, and potential over-torqueing). The working group also found that many of the couplings had safety wire across the bolt end. The safety wire could be helpful if there was a bolt or nut failure (extremely rare events) or the nut was missing. However, the safety wire was of no value when the failure was transverse band cracking and total separation at the spot weld. The data studied by the working group indicated many accidents were due to v-band couplings that were of the multi-segment, spot-welded design, when used in a specific location (the tailpipe to the turbocharger exhaust housing flange on turbocharged reciprocating engine-powered aircraft).

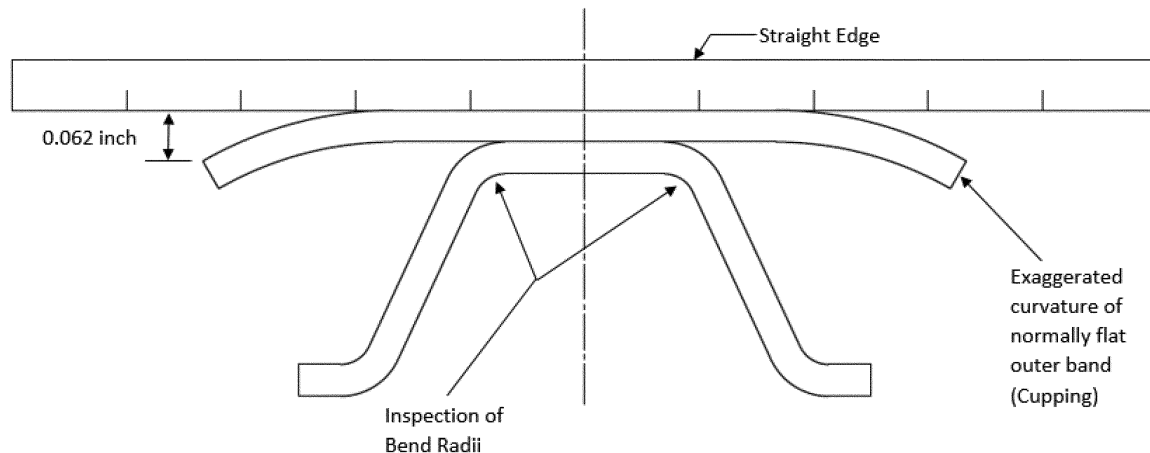
Figure 1 to paragraph (l)(1)(iii) – Inspection Depiction

(iii) Visually inspect the flatness of the outer band using a straight edge. Lay the straight edge across the width of the outer band as depicted in figure 1 to paragraph (l)(1)(iii) of this AD. If the gap between the outer band and the straight edge exceeds 0.062 inch, before further flight, remove the v-band coupling from service and install a new v-band coupling.

(v) Visually inspect the bend radii of the v-retainer coupling segments, throughout the length of the segment, as depicted in figure 1 to paragraph (l)(1)(iii) of this AD, for cracks. If there are any cracks, before further flight, remove the v-band coupling from service and install a new v-band coupling.
