Airworthiness Directive

AD No.: 2023-0136R1

A330 and A340 aeroplanes

ATA 36 – Pneumatic – Overheat Detection System Sensing Elements – Inspection

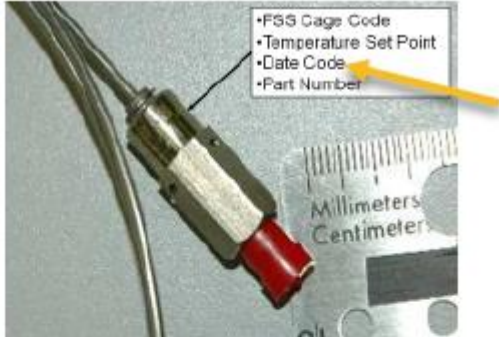
Figure 4-50. Identification Markings on Coaxial SE Male (Pin) Connector

Appendix 1 of this AD provides information how to identify affected parts (P/N and date code).
