**AGÊNCIA NACIONAL DE AVIAÇÃO CIVIL - BRAZIL**

## **BRAZILIAN AIRWORTHINESS DIRECTIVE**

**AD No.: 2021-02-02**

**AD No. 2021-02-02 - YABORÃ / 39-1478.**

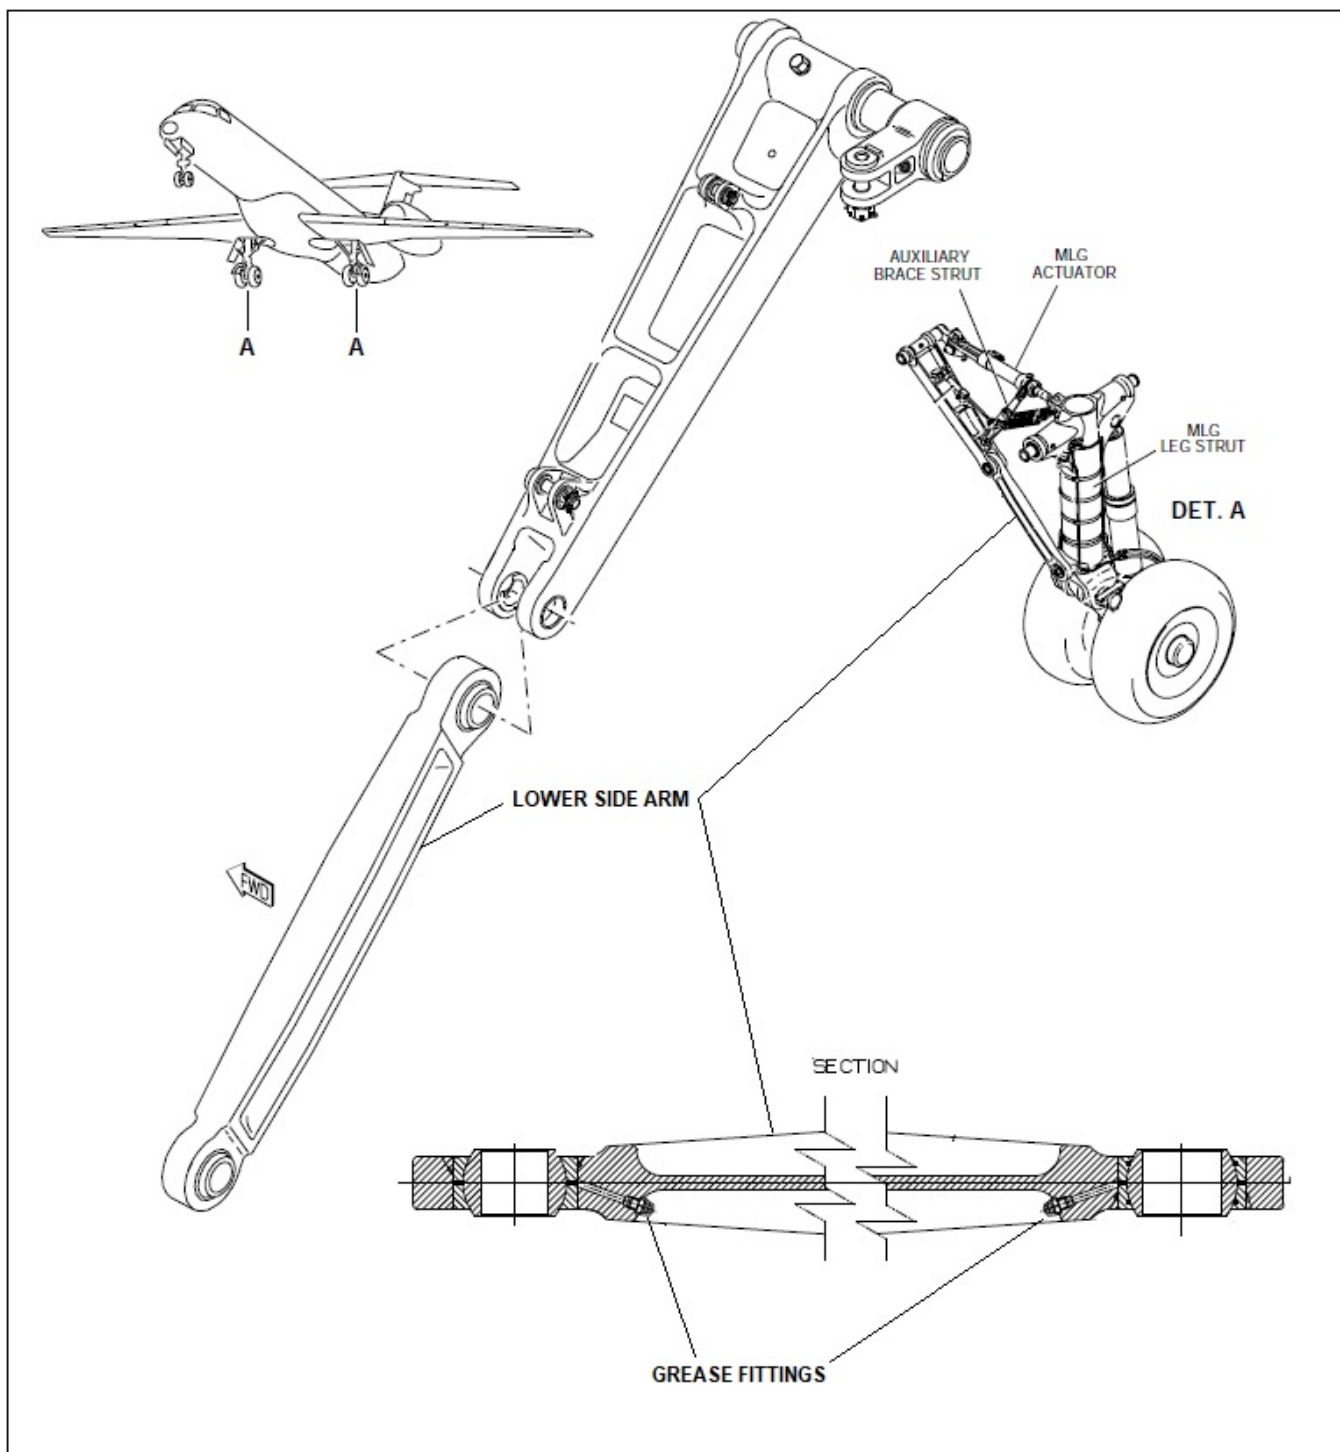
Figure 1: MLG Lower Side Arm correct grease fittings installation

The inspection revealed one occurrence of an MLG Lower Side Arm installed on an aircraft possessing grease fittings on both of its sides. This is not an approved configuration as the MLG Lower Side Arm must have both of its grease fittings installed on the same side (see Figure 1 below).

An MLG Lower Side Arm with grease fittings on both of its sides could lead to a misinterpretation of the MLG assembly instructions which could culminate in an inverted installation of the MLG Side Arm Strut Bearings since the grease fittings installation side on the Lower Side Arm are used as a reference to the correct installation of the Bearings.

A one-time inspection, and replacement of the MLG Lower Side Arm by a serviceable part (see NOTE 1), if necessary, as to the correct positioning of the grease fittings (see Figure 1).

NOTE 1: A serviceable MLG Lower Side Arm (P/Ns 2309-2510-501, or 2309-2510-503, or 2309-2510-505) is one that has both grease fittings installed on the same side of the part (see Figure 1).

1. Verify that both grease fittings are installed on the same side of the MLG Lower Side Arm and that both are facing the flight direction;
  - i. If, during the inspection required by item (a)(1) above, it is found that the grease fittings are installed on opposite sides of the MLG Lower Side Arm (one grease fitting on one side and the other on the opposite side), before the next flight (see NOTE 2), replace the MLG Lower Side Arm by a serviceable part (see NOTE 1). To comply with this paragraph, refer to procedure 32-10-03/400 (MAIN-LANDING-GEAR MAIN BRACE STRUT - REMOVAL/INSTALLATION) of the AMM applicable to the aircraft, and to the CMM (Component Maintenance Manual), procedure T.P. 145/1190\_32-10-03, as necessary;

- ii. If, during the inspection required by item (a)(1) above, it is found that both grease fittings are facing opposite to the flight direction, before the next flight (see NOTE 2), remove the Lower Side Arm and re-install it on the correct position (both grease fittings facing the flight direction – see Figure 1). To comply with this paragraph, refer to procedure 32-10-03/400 (MAIN-LANDING-GEAR MAIN BRACE STRUT - REMOVAL/INSTALLATION) of the AMM applicable to the aircraft, and to the CMM (Component Maintenance Manual), procedure T.P. 145/1190\_32-10-03, as necessary.
