Airworthiness Directive

AD No.: 2021-0107R2

PA-28 and PA-32 aeroplanes

ATA 57 – Wings – Lower Main Wing Spar Caps – Inspection

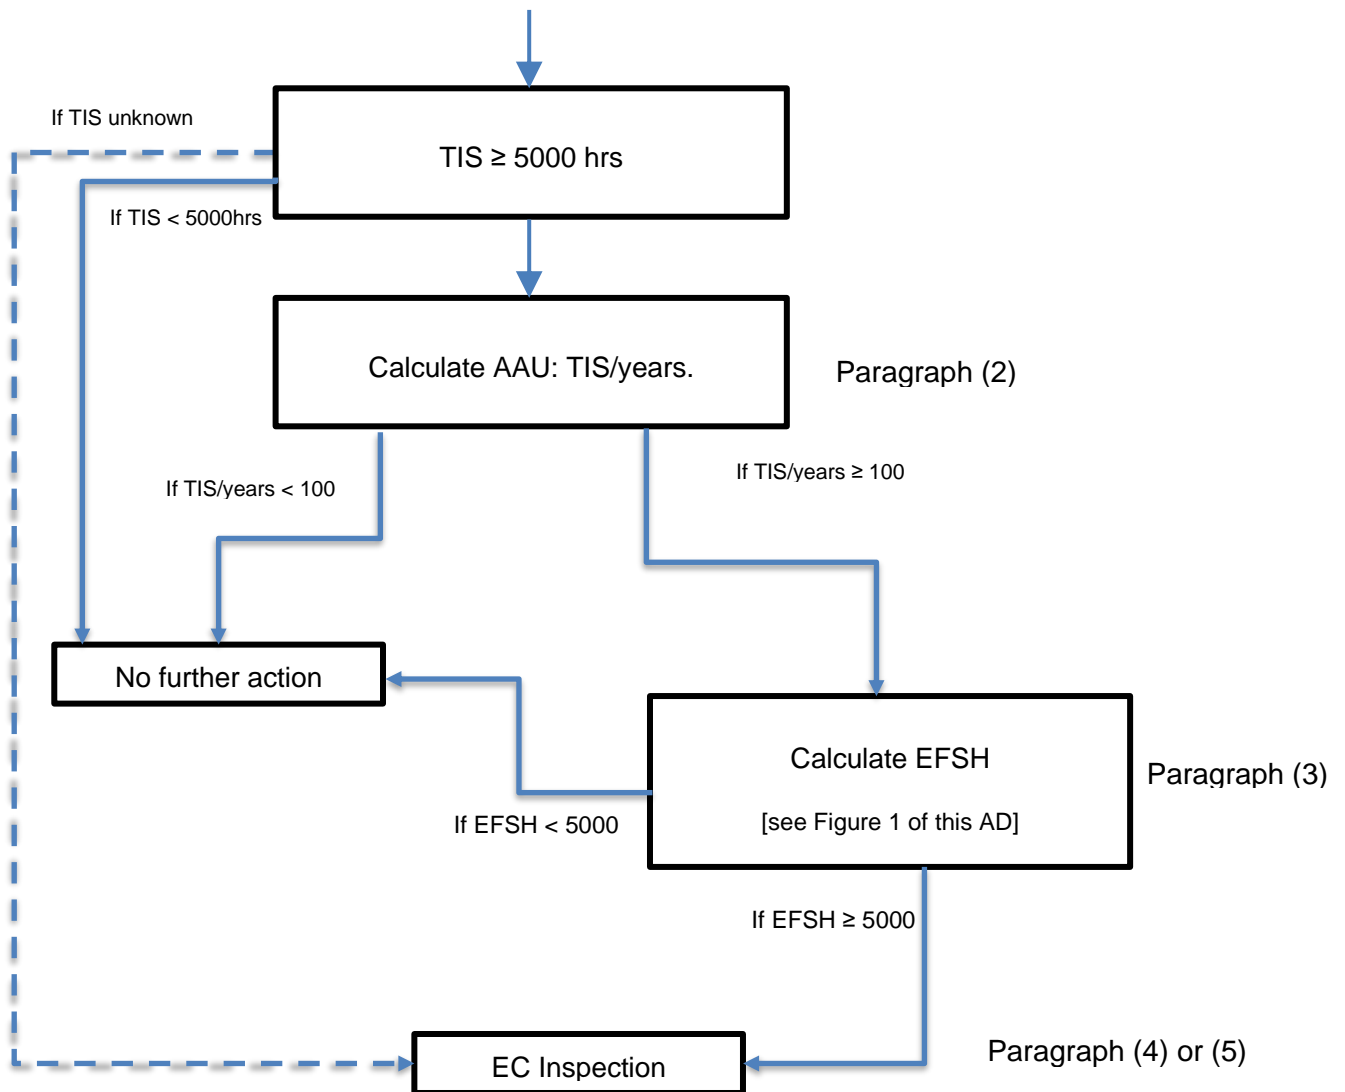
Appendix 2 – Flowchart / Examples of Calculation

Example 1:

For a spar with 55 calendar years and 5 400 hours TIS Hours (TIS=5 100), the results would be:

Example of calendar years: For an aeroplane (or spar, if a replacement spar was installed) that was manufactured in 1989, 1990 is the first calendar year to be counted, and the full year before calculation would be the last, so (if calculated in 2021) the number would be 31.
