Airworthiness Directive

AD No.: 2022-0243

A330 and A340 aeroplanes

ATA 36 – Pneumatic – Overheat Detection System Sensing Elements – Inspection

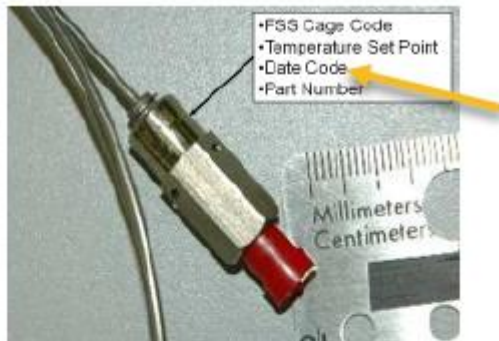
Figure 4-50. Identification Markings on Coaxial SE Male (Pin) Connector

Appendix 1 – Affected Part – Locations of P/N and Date Code

Affected part: Overheat detection system (OHDS) sensing elements, also identified as 'Continuous Fire Detector', having a Part Number (P/N) and corresponding date code as listed in Section 1.A of the VSB, except those that passed an inspection (no discrepancies found; one face of the connector hex nut is marked) in accordance with the instructions of Section 3 of the VSB.
